# Winding Engine House and Headstocks at Bestwood Colliery, Park Road, Bestwood

District:	Gedling
-----------	---------

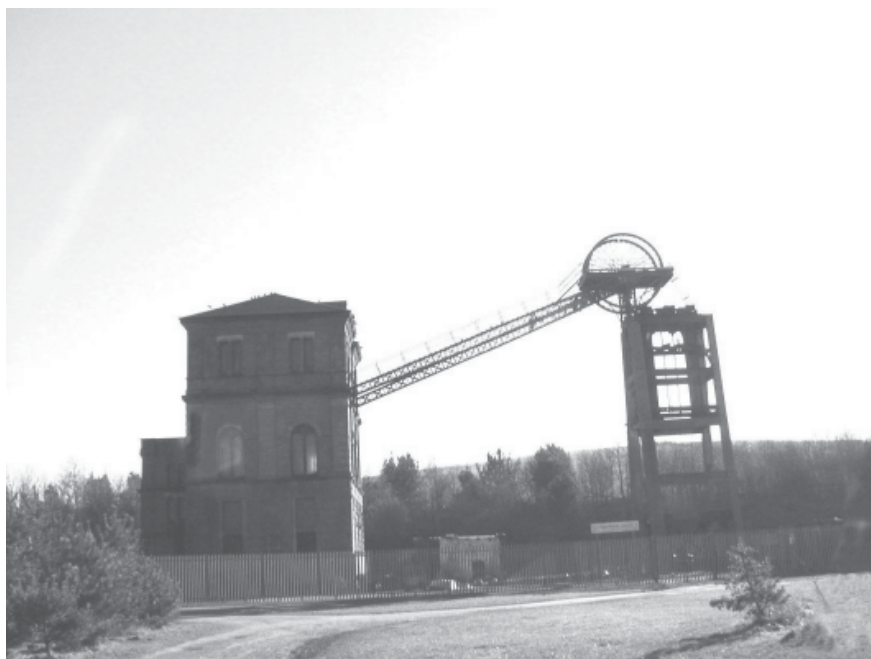
Although the buildings have been maintained since the 1990s by a dedicated volunteer group, they are now in need of specialist repair work. The future is uncertain and due to their isolated location the buildings are under threat of vandalism.

<b>Condition:</b>	Poor
-------------------	------

<b>Risk Level:</b>	At Risk
--------------------	---------

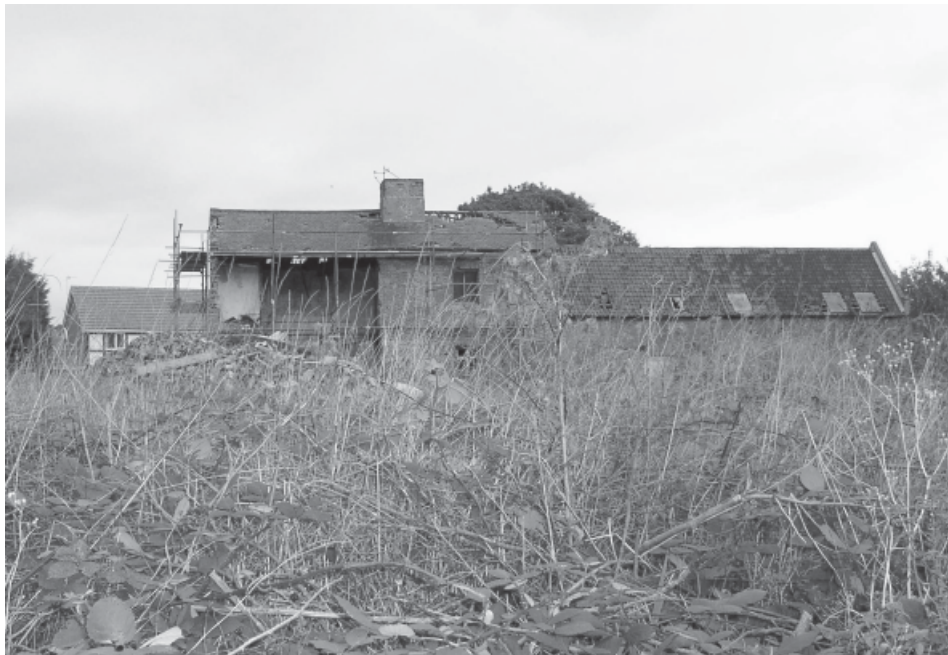
Colwick Manor Farm is in a perilous condition due to the lack of even basic care and maintenance. Weather, time and vandalism precipitated structural problems and the partial collapse of the building. Disaster really struck in 2002 when a tremor caused the two western bays to collapse as well as part of the south elevation of the remaining building, leaving the roof structure and the internal walls exposed to the elements.

<b>Condition:</b>	Very Bad
-------------------	----------

<b>Risk Level:</b>	At Extreme Risk
--------------------	-----------------

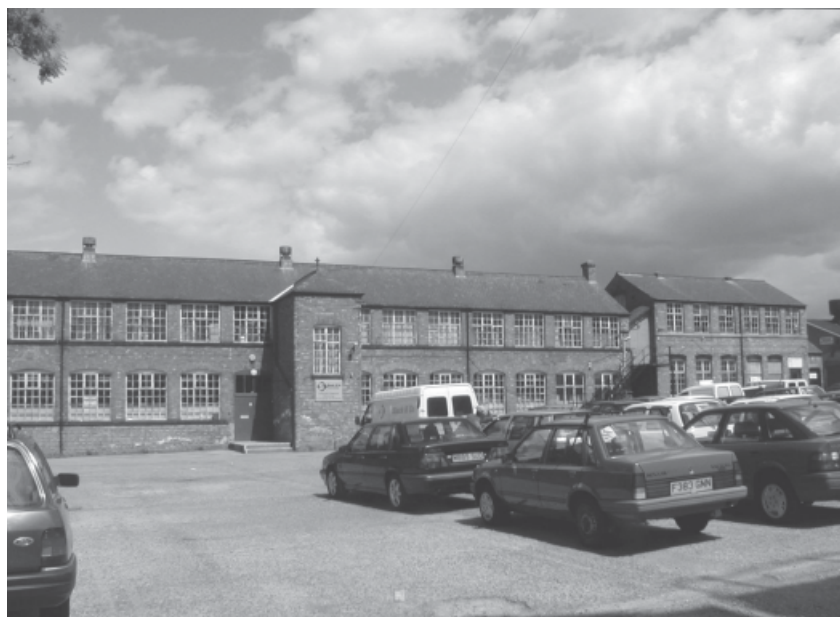
Although the buildings are partially occupied they are in a deteriorating condition due to a lack of maintenance. The rain-water goods are missing or failing, the window frames are rotten and there are some slipped and cracked roof tiles as well as one hole in the roof. There are lots of signs of problems with damp; repointing is also required.

<b>Condition:</b>	Poor
-------------------	------

<b>Risk Level:</b>	At Risk
--------------------	---------

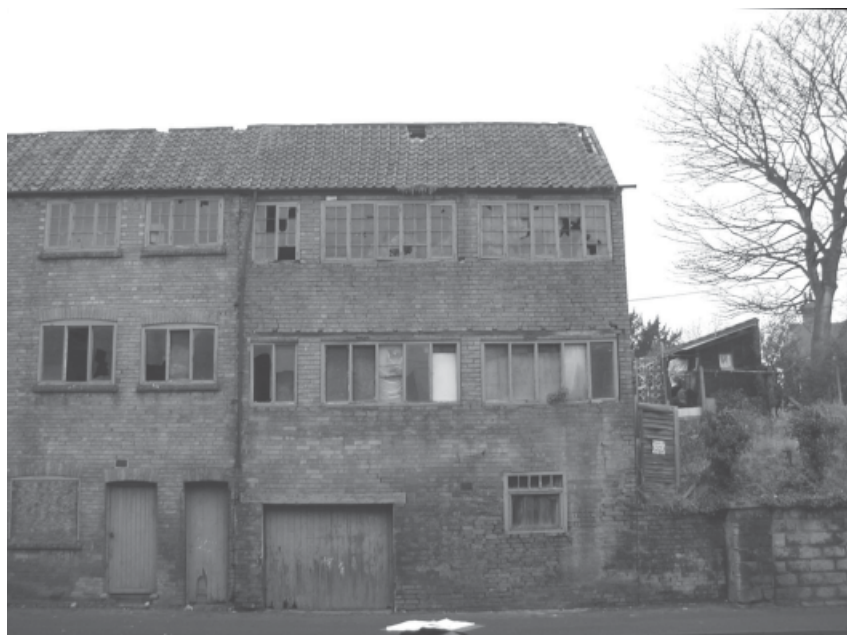
Photo 2001

Long-term under-use and lack of maintenance are causing problems at this site. Apart from the upper floor windows, which have been repaired in 2003, the windows are boarded up and the frames are rotten. There are structural cracks in the walls with large areas of eroding bricks and missing pointing. In 2003 the roof and rainwater goods were also repaired and the building mothballed.

Condition:	Poor
------------	------

Risk Level:	At Risk
-------------	---------

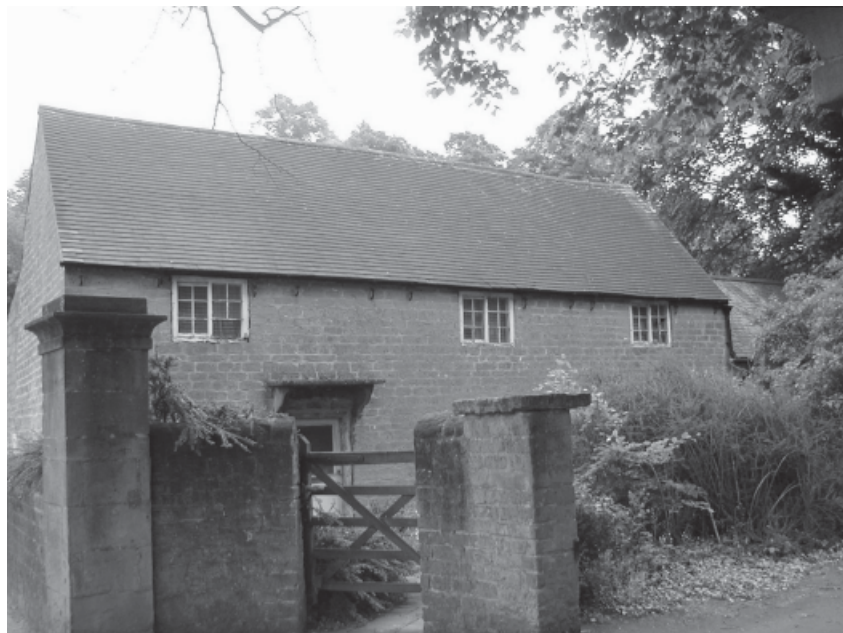
The roof and walls are in a fair condition but the window frames are rotten, some panels are broken and one window is boarded up. The house has a general run-down appearance.

Condition:	Poor
------------	------

Risk Level:	At Risk
-------------	---------
