List of Monuments and Structures at Risk

Listed Structures and Monuments at Risk in Ashfield

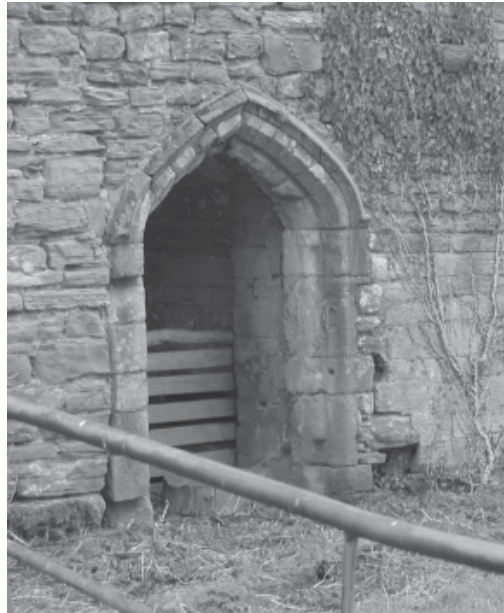
*Image: Detail of the Prior's House, Remains of Beauvale Priory (Greasley);
image opposite: Gatepiers at Gatehouse Lodges (Drakeholes, Wiseton).*
