Lost Buildings

The Buildings at Risk survey provides the natural opportunity to take a look at changes to the fabric of Nottinghamshire's Built Heritage. Unfortunately some of these changes include the loss of a number of the county's historic buildings. The following pages show a selection of these and illustrate the reasons for loss.

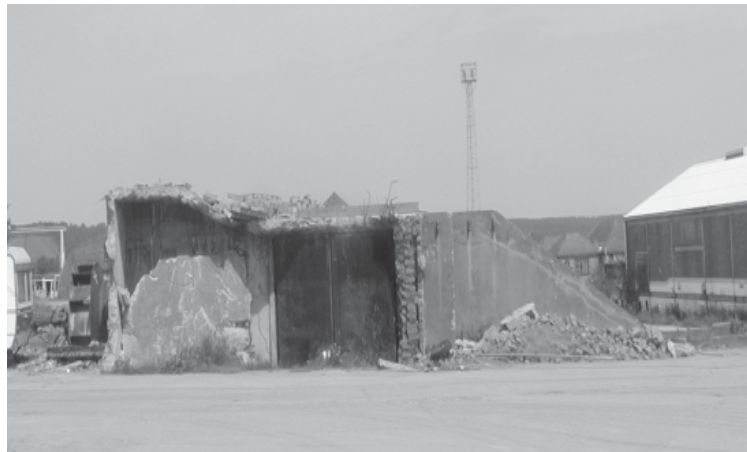
Image: A former shed at Annesley Colliery (Annesley), vandalised and illegally demolished in 2004; image opposite: Detail of Colwick Manor Farm (Colwick), see also p.85.

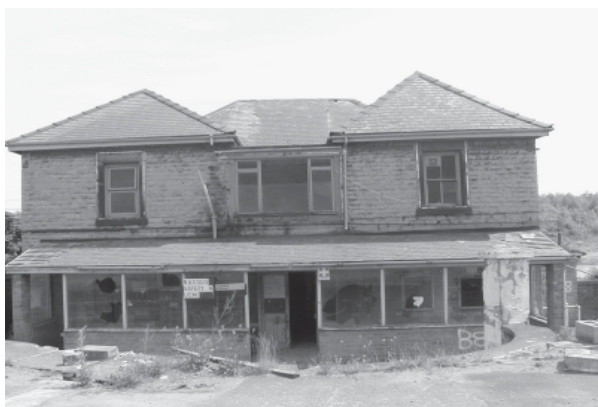
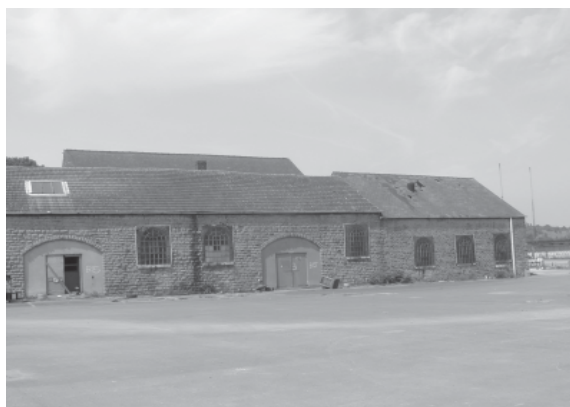
Annesley Colliery Buildings, Annesley

This collection of pit buildings at the site of Annesley Colliery (some of which date to the late 19th century) have recently been illegally demolished. Annesley was the oldest working pit in the county when it closed in 2000 and the site was subsequently designated a conservation area. Not all buildings were individually of architectural interest but as a group they had a high heritage value in industrial archaeology terms.

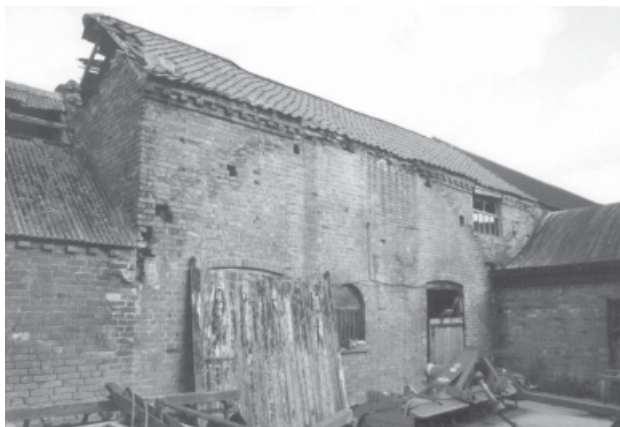
Stable at Grange Farm, Marnham

This red brick and pantile stable range dates from the early 19th century. They are part of a listed range that includes two unusual covered crewyards.

In the resurvey the crewyard was noted as being at risk. In the course of repairs being carried out it was discovered that the stable range behind had been partially demolished after the roof structure had given in after a storm.

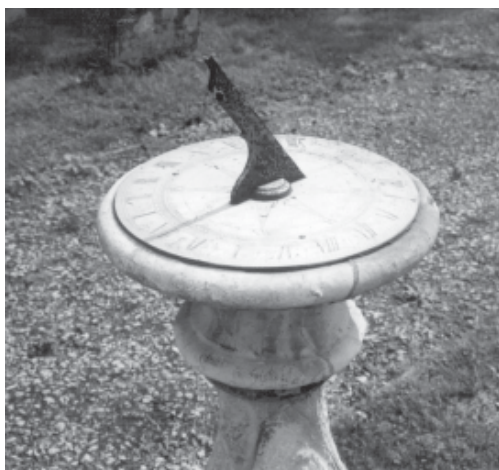
Sundial in Churchyard at Ossington

This Ashlar sundial dated 1812 consisted of a vase baluster stem on moulded base and bronze dial.

In the re-survey it was noted that only the moulded base was in situ. Further investigations unfortunately revealed that the object had been stolen. Structures in isolated positions, like this, are extremely vulnerable.

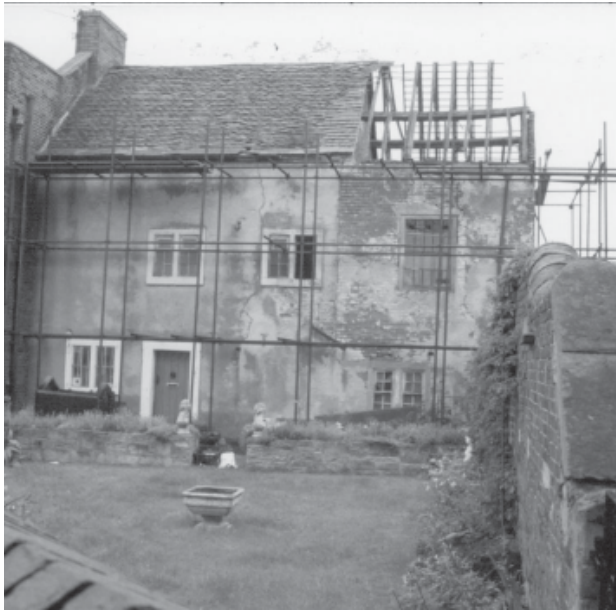
Service wing at Dalestorth House, Skegby

This late 18th century wing to Dalestorth House had been at risk since its listing date. The building was demolished by the time of the first Buildings at Risk survey in the county.

As the picture shows, there were some structural issues and the building was partially unroofed.

Although the demolition was carried out legally it is highly unlikely that a building like this would gain consent for demolition today.

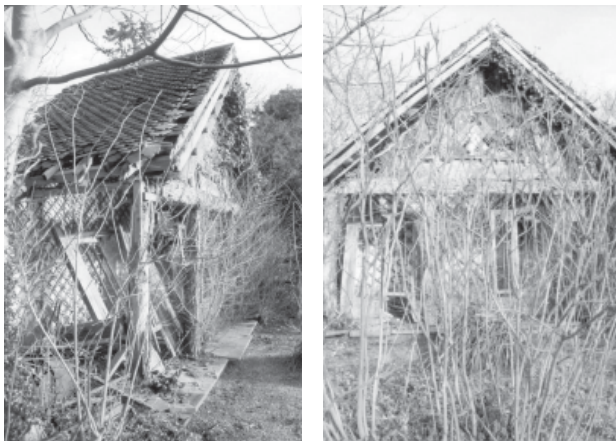
Summerhouse at Dunham House, Southwell

The early 19th century gothick summerhouse at Dunham House had been at risk in 1991 (date of photos).

Lack of use and maintenance had contributed to the structures vulnerability and on revisiting the property in 2002 it was found to have collapsed following a storm.

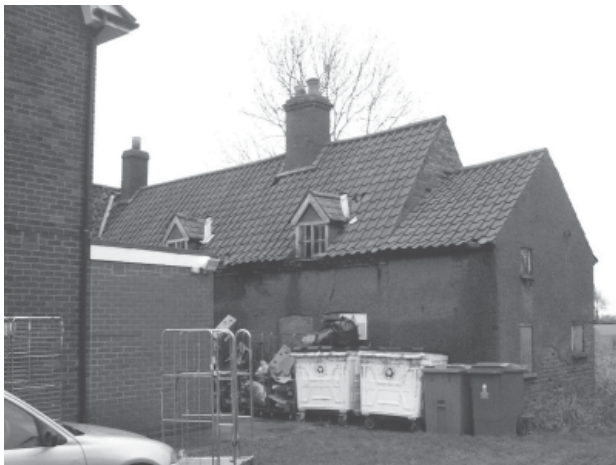
61 - 65 High Street, Sutton on Trent

This late 18th century group of cottages was a long standing problem. It was awkwardly located to the rear of a late 20th century shop building, restricting its potential for reuse. The building was deemed to be a dangerous structure.

No scheme was found to secure its future and in 2004 permission was granted for an application to demolish.
